SERVICE INFORMATION

Nr. 02_04

Wiring Fastening for Clutch Actuator on ASTRONIC Transmissions

New Housing Seals in ASTRONIC 2 Transmissions

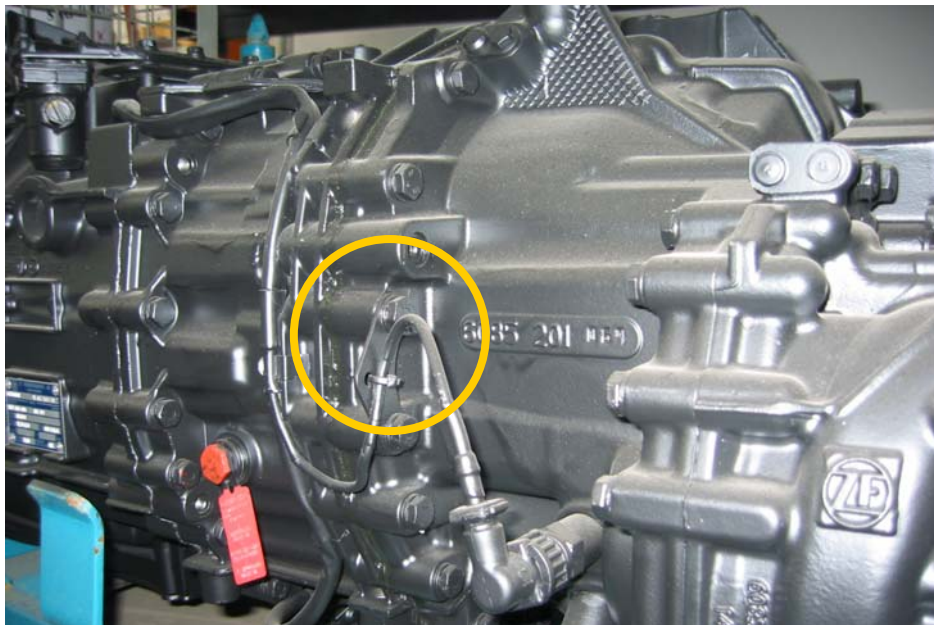
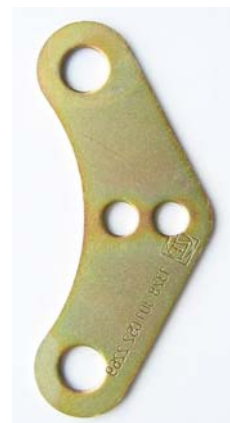
OLD fastening of wiring

During the course of further development work, the wiring fastening for the clutch actuator was modified. The two retaining plates, to which the cable harness was previously attached by means of cable clips, were discarded in two modification stages. They have been replaced by cable clamps. A modification related to this has also been undertaken on housing section 2. The new housing section 2 has been introduced to volume production by modifying the parts list and using new item numbers.

Fixing device
1328 301 052

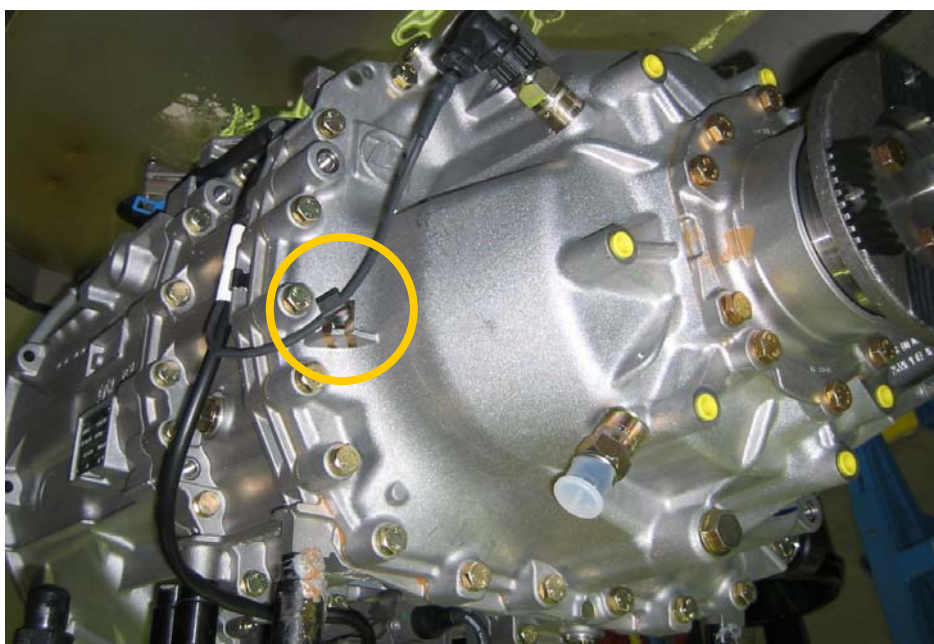
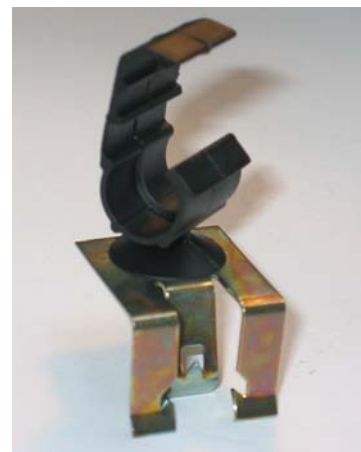
NEW fastening of wiring

Fastening
0501 214 086

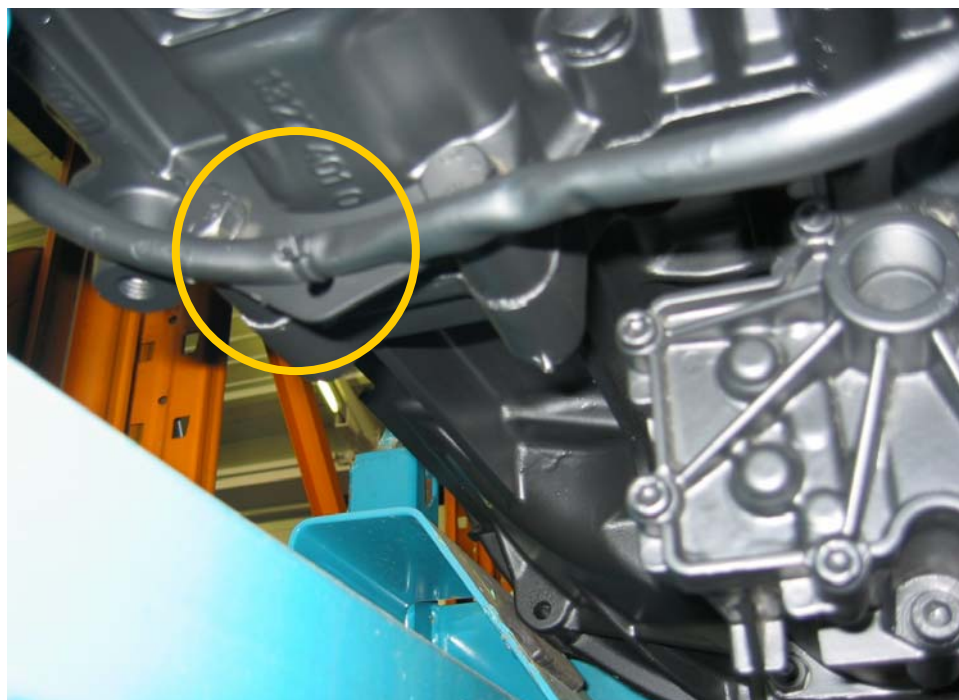
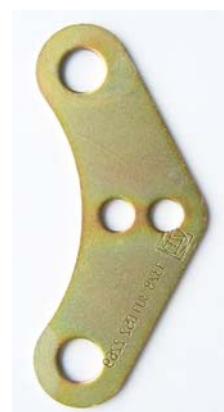
OLD

Fastening for wiring (underside of transmission, second modification stage)

Fixing device
1328 301 052

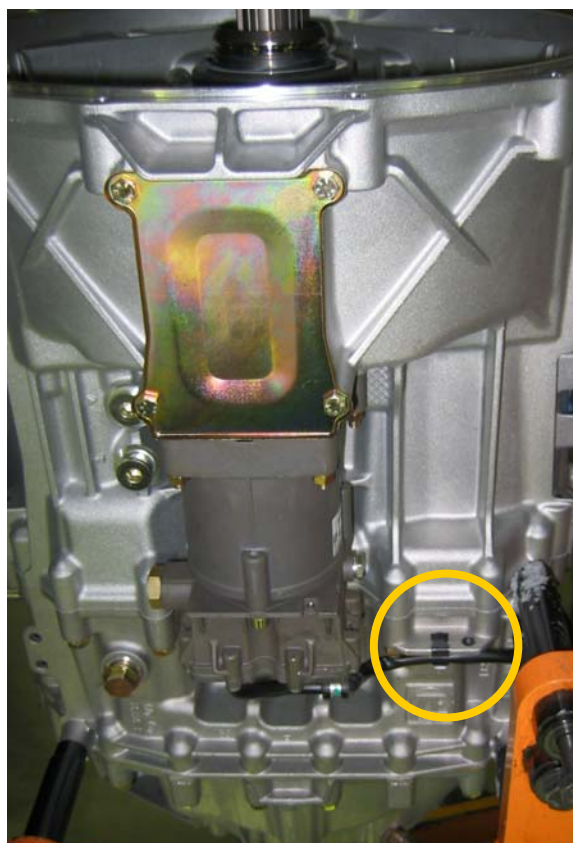
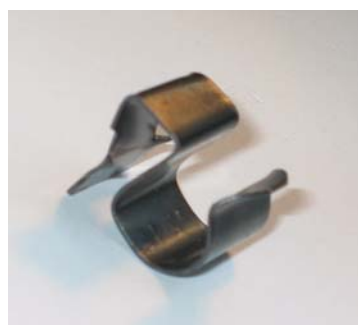
NEW

Cable clamp 0659 050 410

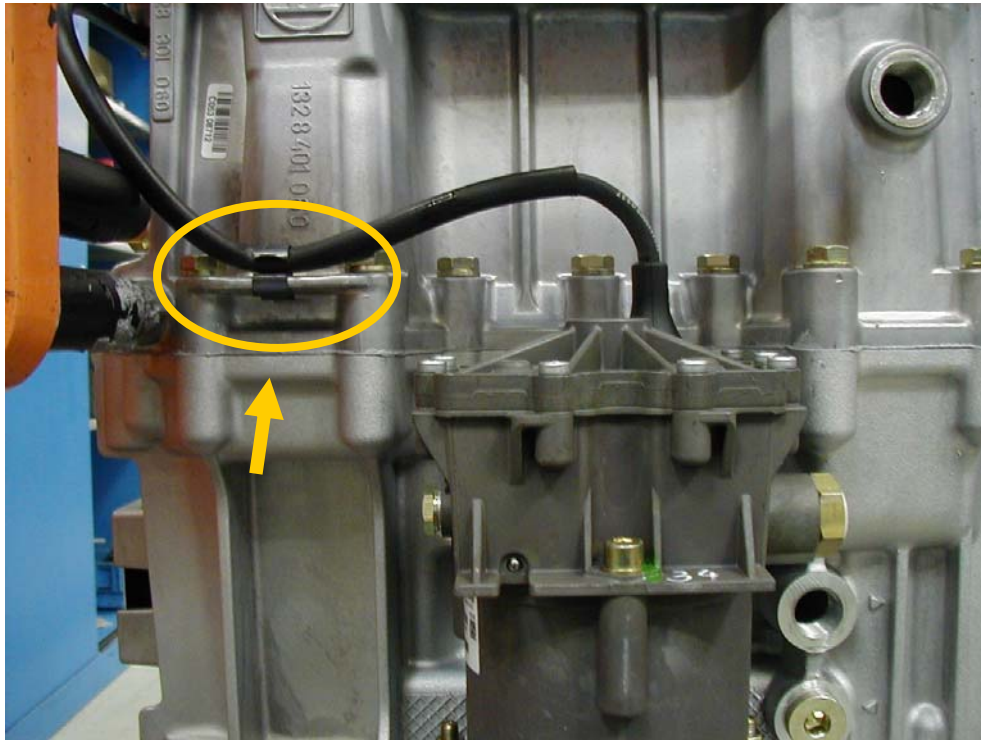
Modified point on housing 2

| Designation | Item number | Remark |
|---|---|--|
| Fastening | 0501 214 086 | available, can only be fitted on new housing 2 |

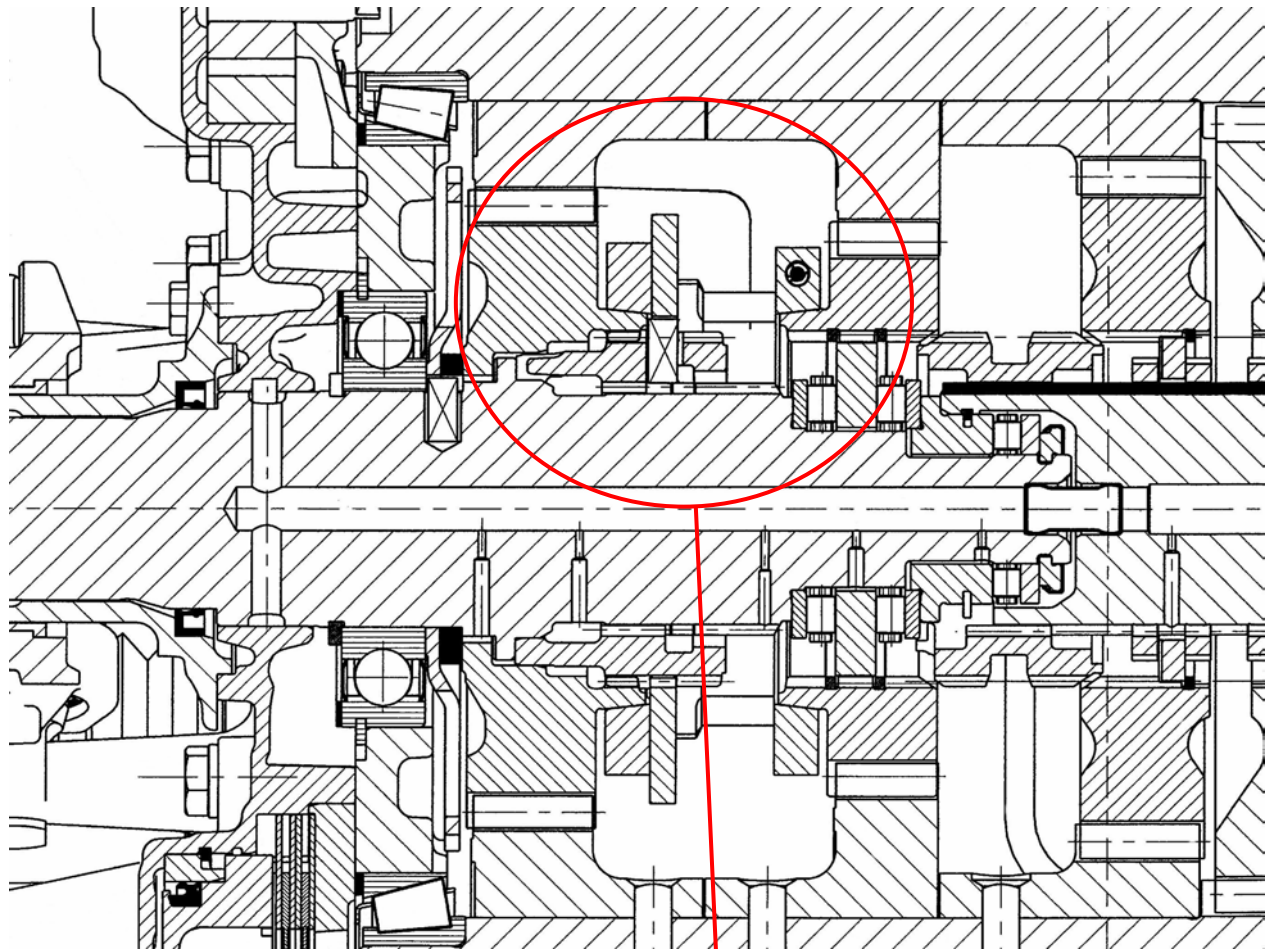
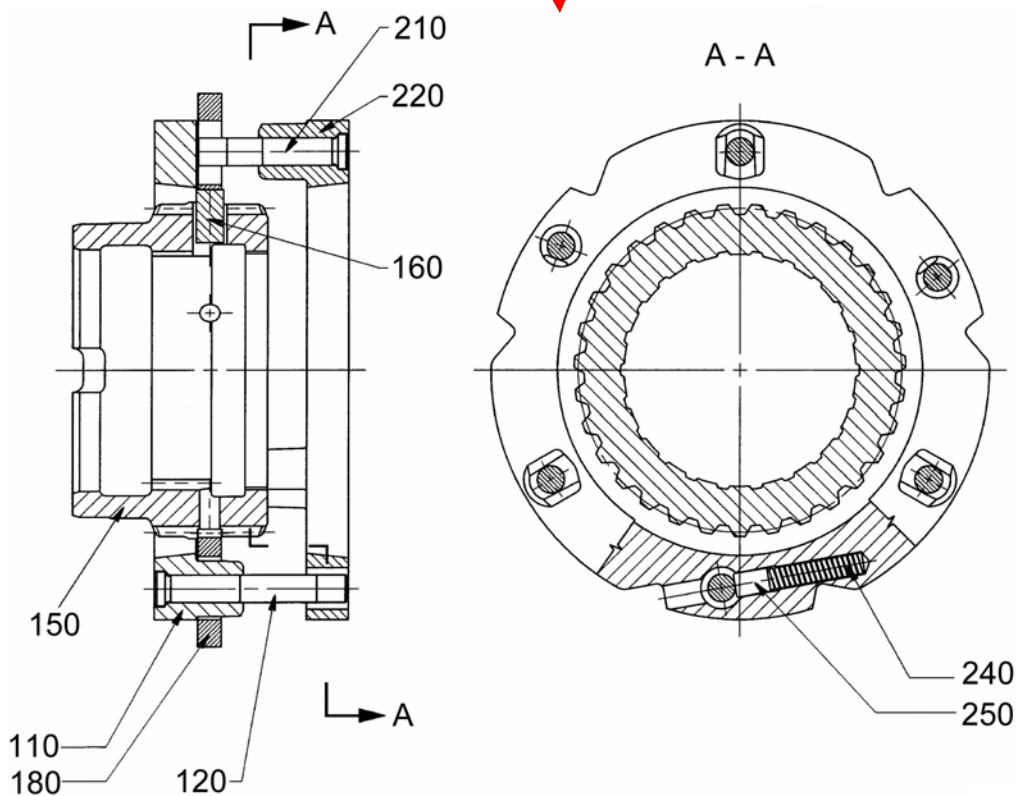
During the course of further development work, the splitter group synchronizer unit in the ASTRONIC 2 transmission has been further optimized. The design of the synchronizer rings and plate has been changed. To ensure uniformity, the synchronizer rings and plate of the synchronizer unit in the ASTRONIC 1 transmission have also been modified.

Sample sketch of installation situation of splitter group synchronizer unit in ASTRONIC 2 transmissions

In the event of repairs, the synchronizer rings and plate should always be replaced in complete sets. Old and new components must not be combined with one another. Old parts may be used up.

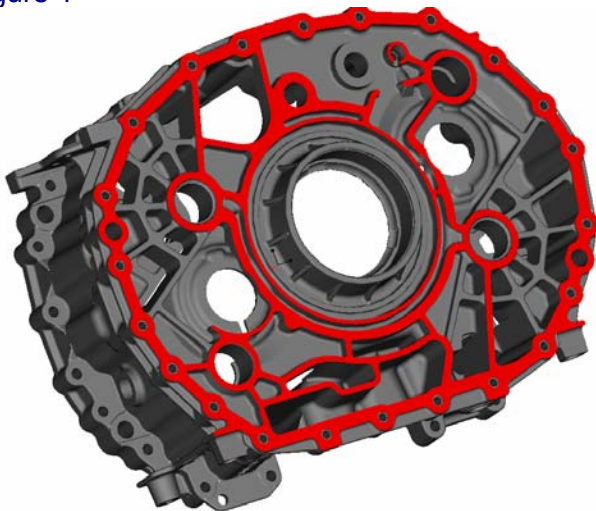
Figure 1

- **OLD** Assembly with liquid gasket

Housing sealing face and thrust surface of GP plate at the same height

**Old housings must be fitted with liquid gaskets,
New housings must be fitted with solid seals (2 metal gaskets).**
